RAPID BIOASSESSMENT OF THE
UPPER LAUGHERY CREEK WATERSHED
USING BENTHIC MACROINVERTEBRATES

for the Soil and Water Conservation Districts of
Franklin, Decatur and Ripley Counties

Study Conducted During
July and October 1994

Commonwealth Biomonitoring
7256 Company Drive
Indianapolis, Indiana 46237
(317) 887-5855

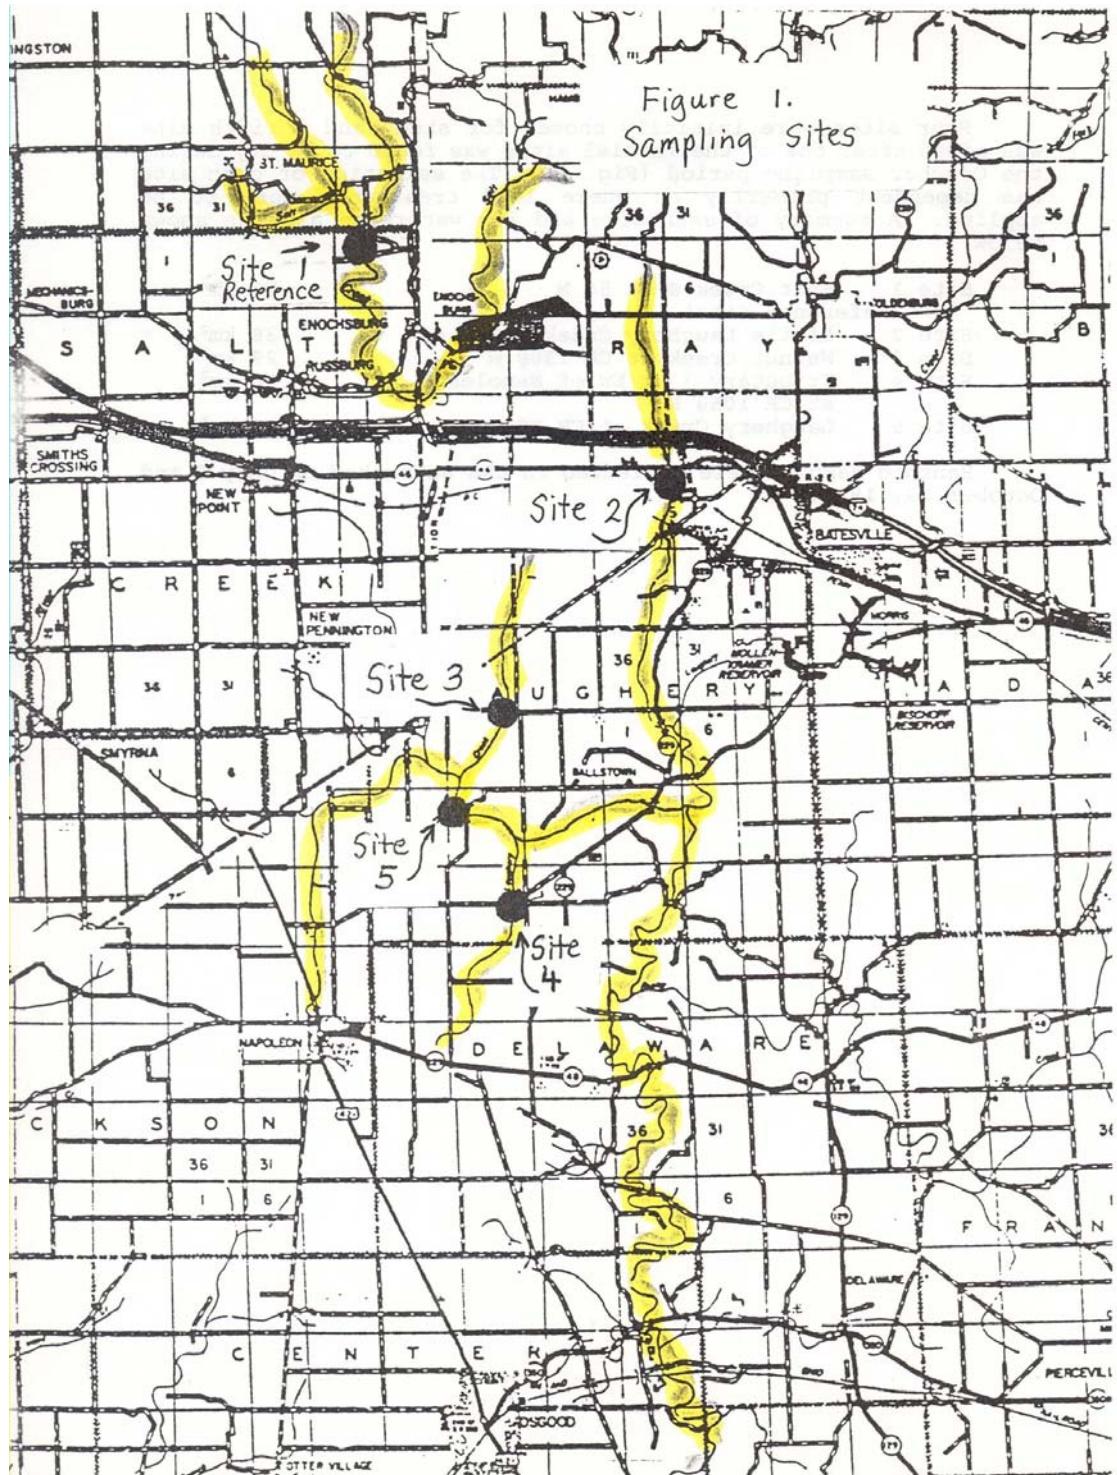
Four sites were initially chosen for study and a fifth site was added after one of the initial sites was found to be dry during the October sampling period (Fig. 1). The selection of each site was dependent primarily on where land treatments were to be applied. A summary of each site and its watershed area is shown below:

Site 1	Salt Creek @ CR 50 N (Reference Site)	72 km ²
Site 2	Little Laughery Creek @ Hwy 46	38 km ²
Site 3	Walnut Creek at CR 1300 N	29 km ²
Site 4	Tributary 3 km NW of Napolean at CR 1050 N	16 km ²
Site 5	Laughery Creek at CR 200 W	80 km ²

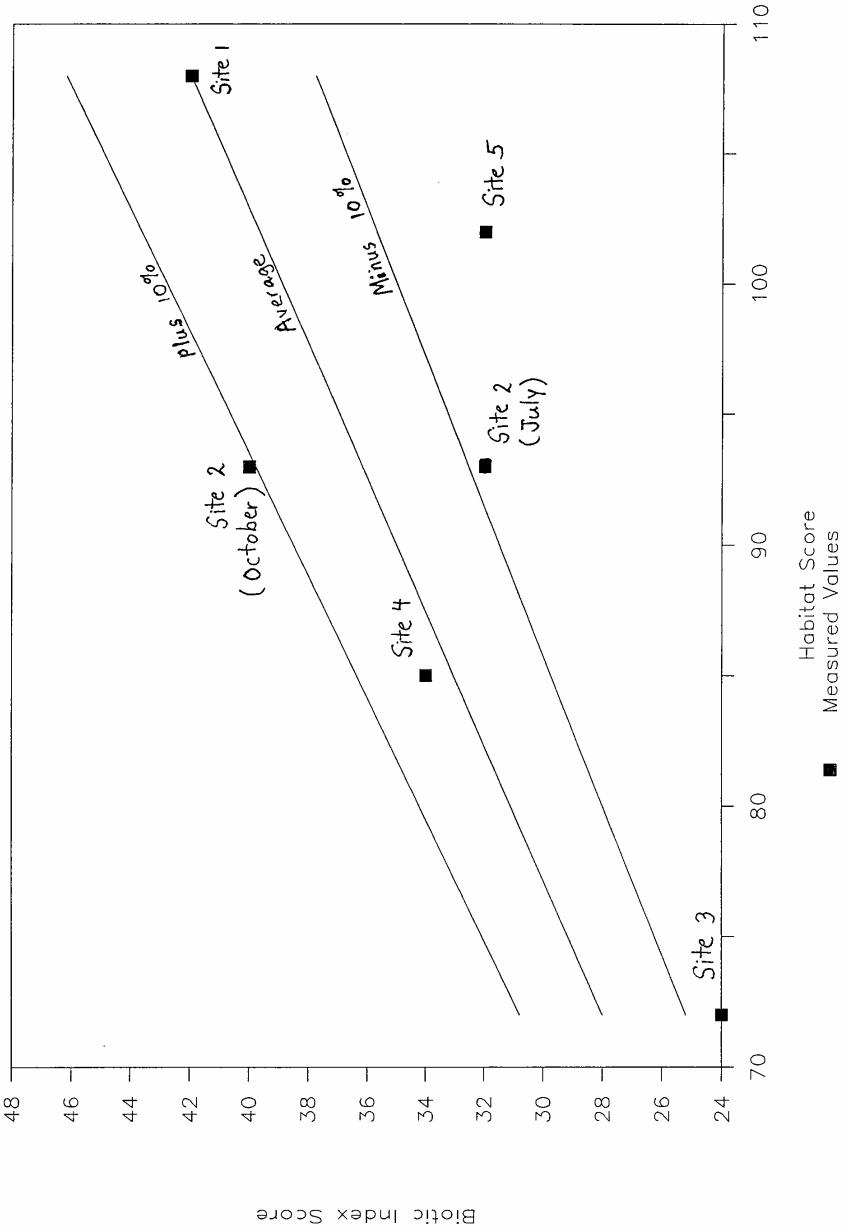
Figure 2
Biotic Index vs. Habitat Score

Figure 2 shows the normal relationship of biotic index scores to habitat values (a linear relationship according to [4]). The figure also shows a range of plus or minus 10% to account for a certain amount of measurement variability. When biotic index values fall outside this range, the site typically has degraded water quality. Figure 2 indicates that during July sites 2 and 3 had biotic values significantly lower than expected from their measured habitat values. This was also true at Site 5 during October. Therefore, these sites were probably affected by both degraded habitat and degraded water quality. The graph suggests that Site 4 probably supports an aquatic community as good as its present habitat allows.

An examination of those metrics showing the greatest difference from the reference stream may provide an important clue about causes of biological impairment at sites 2 and 3. The largest differences at these sites occurred in the EPT/Chironomid ratio and the % shredders metrics. The decline of EPT organisms and a concurrent rise in chironomid abundance is associated with several kinds of environmental degradation. For example, several studies have shown this metric to be associated with instream toxicity [6]. However, changes in other metrics commonly indicating toxicity problems (e.g. a reduction in the number of taxa) were not observed and few "toxic indicator" organisms were observed at any site. A more likely explanation for this shift in the types of animals present is stress caused by stream sedimentation or nutrient enrichment, often associated with agricultural runoff. Such changes favoring chironomids at the expense of EPT taxa have been observed in other studies [8].

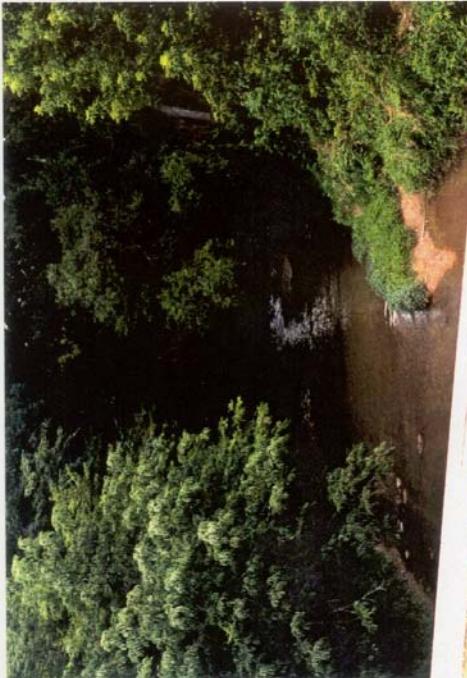
Salt Creek - Site 1
Reference

The aquatic community of a reference site is compared to that of each study site to determine how much impact has occurred. The reference site should be in the same "ecoregion" as the study sites and be approximately the same size. It should be as pristine as possible, representing the best conditions possible for that area. Salt Creek in Decatur and Franklin Counties was chosen as the reference site for this study. Its watershed area is about 72 square kilometers, which is similar to that of most study sites on Laughery Creek, and it is located only a few kilometers north of the upper Laughery Creek watershed. Salt Creek is known to support an extremely diverse fishery, including many "intolerant" species [5]. Therefore, its habitat and water quality are probably among the best available within this area. Agriculture is an important land use in the Salt Creek watershed, but the upper portions of this stream retain a more natural riparian corridor than most Laughery Creek tributaries.

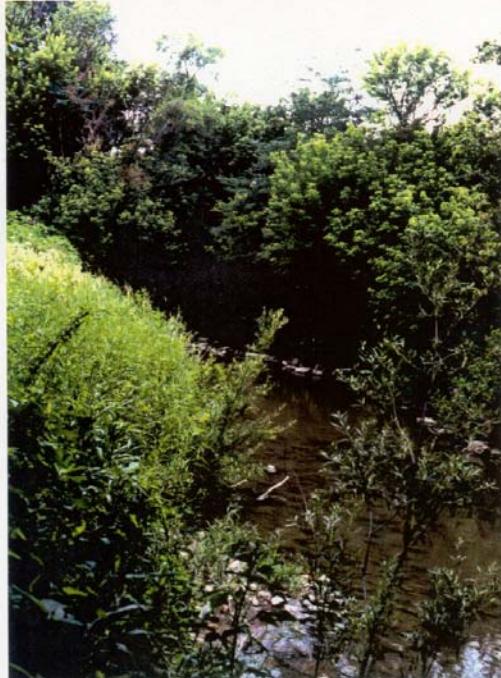
Walnut Creek
Site 3

The scores indicate that the lowest habitat value in this study was at Site 3 (Walnut Creek near CR 1300 N). Habitat at this site was hampered most by a paucity of stable bottom substrate. In addition, this site became almost completely dry during the late summer and the benthic community could not be sampled during October. All study sites also suffered from various degrees of channel alteration, lack of shading, and sediment deposition.

2. Site 3 on Walnut Creek dries up during dry, low-flow conditions. Because the rapid bioassessment technique can be used successfully only in flowing streams, monitor this site only in spring or early summer.

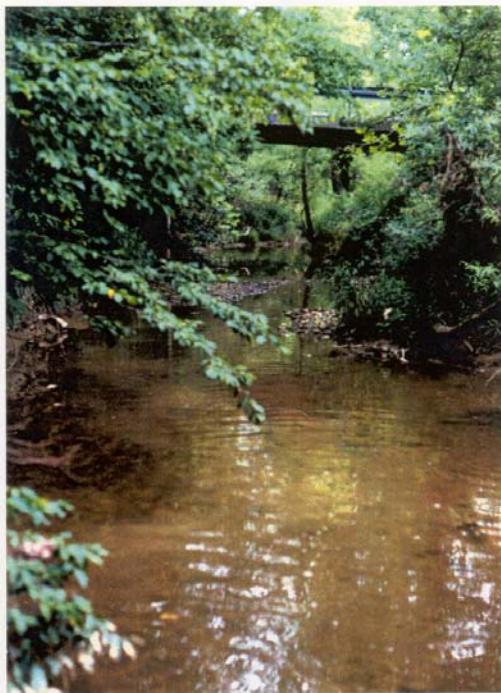
Unnamed Tributary
Site 4

3. Despite its very small watershed area, the unnamed tributary at site 4 has more-or-less permanent flow and appears to be spring-fed, with high water quality. Since Laughery Creek has few such tributaries, this stream is worthy of continued protection and enhancement.
